# 2014 STORM WATER MASTER PLAN UPDATES

*October 20, 2014  
SDA Job No.: NV13007*

**Prepared for:**  
**City of Novi**  
Department of Public Services  
Engineering Division  
26300 Lee BeGole Drive  
Novi, Michigan 48375  
(248) 347-0454

## 2014 STORM WATER MASTER PLAN UPDATES

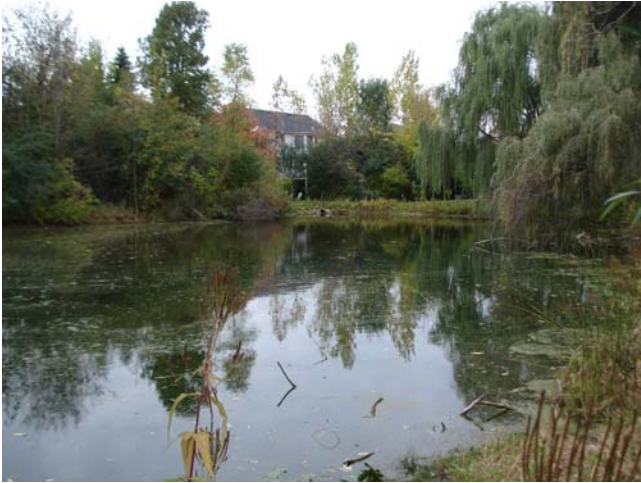
*Lexington Green Detention Basin Outlet*

The basin inlet and outlets were located and appear to be in fair condition, without excessive sedimentation or other restrictions. The route that overland flow water takes when the pond banks are overtopped was walked, and crosses behind several homes along Galway Drive.

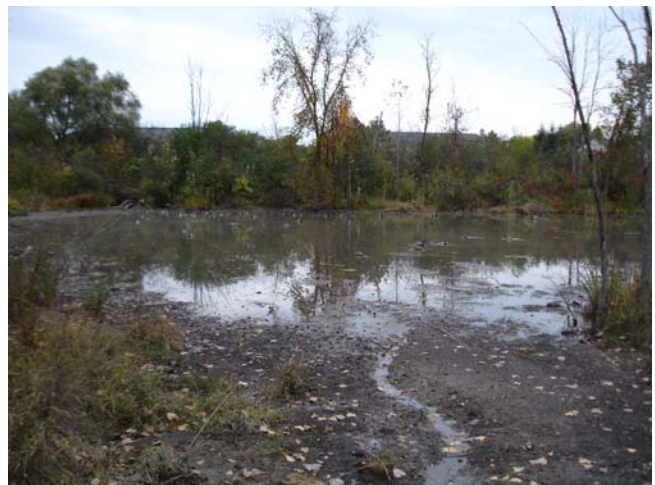
The Pheasant Ridge wetland pond and outlet to the Randolph Street Drain were examined, and sediment was observed at the upstream invert.

*Pheasant Ridge Wetland Pond – heavy sedimentation*

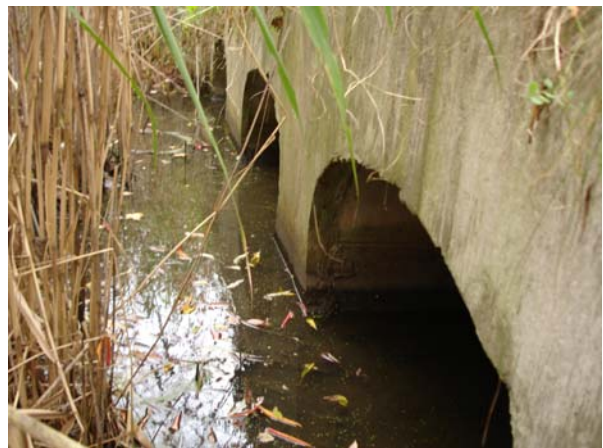
Water leaving the detention pond flows westerly through the wooded wetland, continuing to the west through culverts crossing under Novi Road, which consist of three 43-inch-tall, 68-inch-wide elliptical culverts. There are also two culverts south of this crossing which appear to function as an overflow for the wetland area, and were observed to be dry.

*Novi Road Crossing*

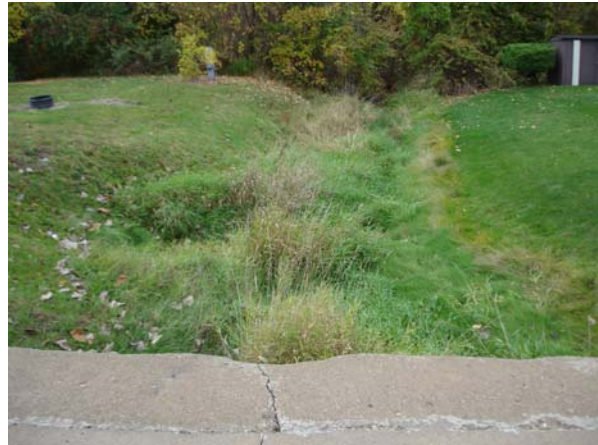
These locations were surveyed on November 18, 2013, and it was found that across this drainage area, there was approximately 4 feet of fall from Oakland Glens to Walled Lake, which is a distance of approximately one half-mile. This is a very shallow slope (0.15% average) which likely contributes to the flooding by backing up

*Outlet under Montmorency Drive*

water into Oakland Glens. Based on this information, there may not be a feasible solution to completely control the flooding. Remediation options are described later in the report.

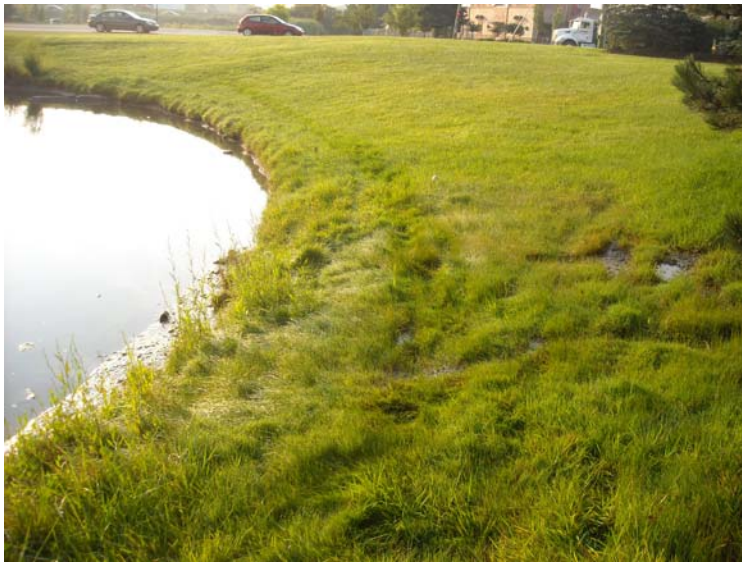
Basin #1 showed no apparent sediment accumulation. Only two small (~10' to 30' long) areas of shoreline erosion were observed, and they did not appear to be contributing significant amounts of sediment to the basin. DPS staff commented that the Sheraton hotel

*See page thru South Slope Basin #1*

standing water from seepage through the basin side slope. Long term, this seepage could cause issues with bank erosion.

5. Retrofit outlet of Basin #1 to permit lower water levels: Remove the existing restriction on the outlet to allow the normal water level to be lower and install a standpipe with stone inlet cone. This would restore Basin #1 back to its original design and functionality as a detention basin, with storm surge capacity and fluctuating water levels. Prior to implementing this, it is recommended that the downstream hydraulics be reviewed to ensure that the increase in discharge will not adversely affect the downstream Basin and surrounding area.

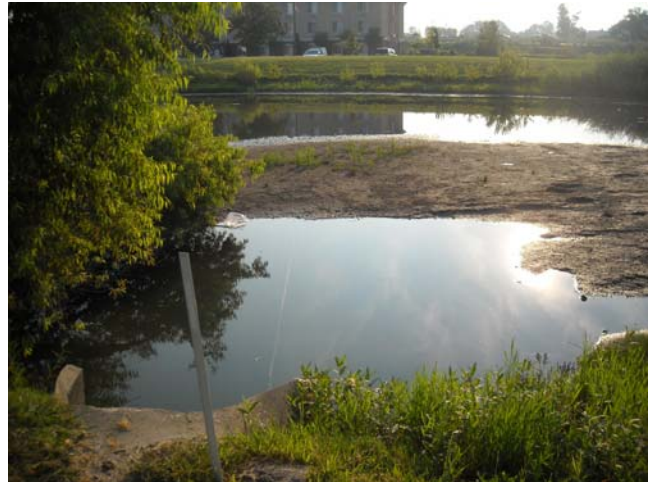
Basin #2 showed signs of a significant accumulation of sediment. Although flow through the outlet structure was observed, there is significant sediment and plant debris in the pond that adversely affects the storage volume and operation of the basin. DPS staff stated that they could not recall if the basin had ever been dredged.

*Sediment Accumulation at Basin #2*

The DPS staff also stated that the 6-inch diameter outlet pipe of Basin #2 clogs and requires frequent maintenance. There is also pipe separation at the southwest inlet of this basin.

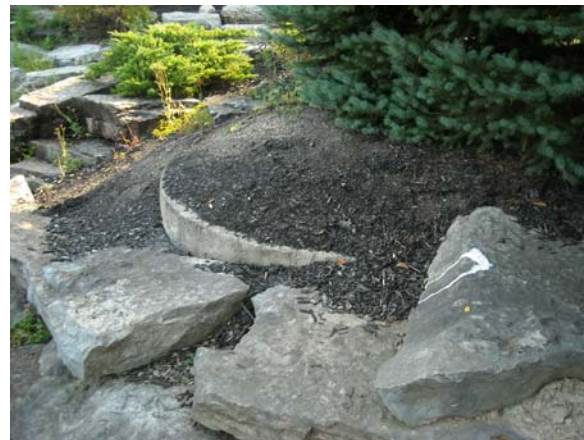
Each of the located structures were mapped using GPS and are shown on the included map. One structure (Inlet #1) was not able to be located; however, DPS staff provided us with an approximate location (east end of Village Oaks Lake). The individual structures were difficult to locate due to the landscaping, steep terrain, and improvements installed by the homeowners.

*Structure surrounded by Landscaping*

1. Acquire Easements, Repair / Replace Deteriorated Infrastructure: Drainage easements for access and maintenance should be acquired by the City from the individual homeowners and/or the Homeowners Association, as applicable. It is estimated that nine easements will be necessary to provide adequate access for both lakes. These can be negotiated individually or acquired through condemnation. Obtaining these easements would be necessary in order for the City to perform immediate and on-going maintenance. The inlet and outlet structures could then be accessed directly for heavy rehabilitation or full replacement. Significant grading will be needed to develop working areas at some structures. Due to the proximity to private property or impassible slopes, working from the water via boats or a small barge may be required.

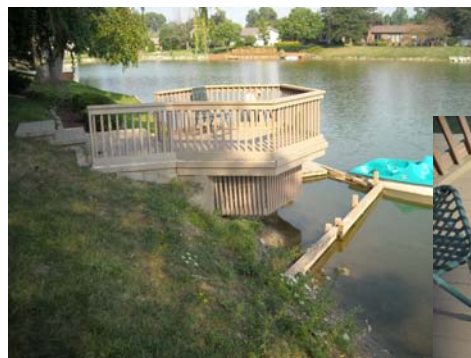
Structures were located in difficult to access areas, such as under large pine trees and, in one case, under a deck / overlook. Some inlet pipe end-sections were submerged, and therefore were not visible for observation.

*Deck built over Structure*

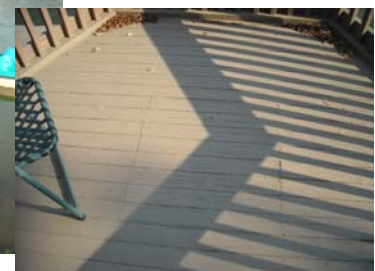
*Access hatch in deck*

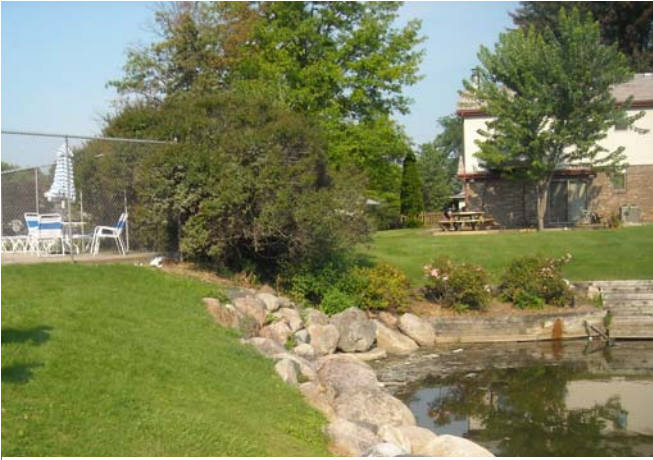
*Village Oaks Lake Outlet Structure Hidden by Landscaping*

The outlet structure of Village Oaks Lake is located under heavy brush and the pipe is not visible due to a thick layer of stone rip rap. The outlet structure of Village Wood Lake had recently been repaired by the City, and additional rip rap was placed around the structure. The outlet structure and overflow are located in the Village

2. Repair / Replace Village Oaks Lake Outlet Structure: The outlet structure of Village Oaks Lake is in poor condition. The structure can be replaced with a new structure of the same size in the same location assuming that there are no problems with the current outlet and capacity of the structure (none were reported). If there are known capacity issues, a hydraulic analysis should be completed for the contributing area to the lake and the new outlet structure sized accordingly to improve the hydraulics of the area.

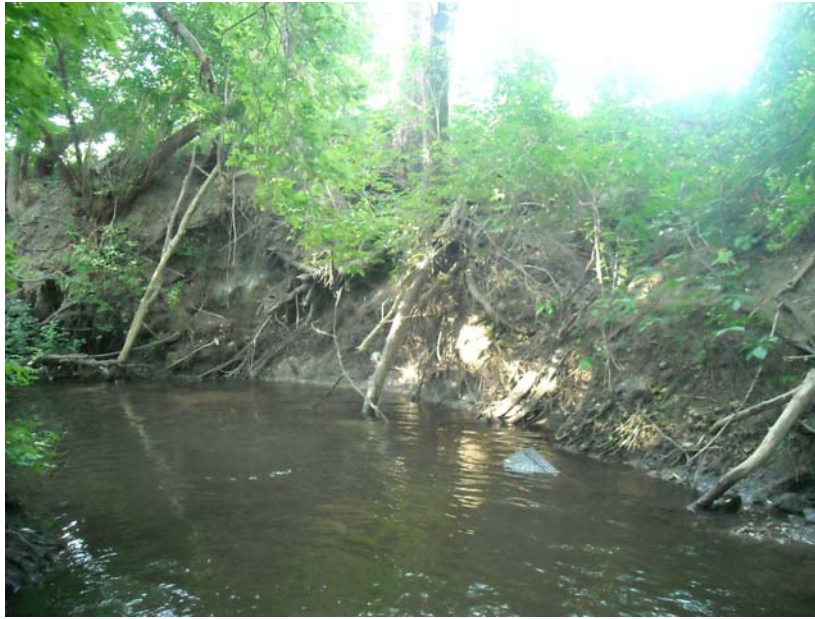
Picture: 365

Outside Meander Erosion, looking downstream, Bank Height = ~ 10', BEHI = 34/Very High

Location: **Middle Branch Rouge River**

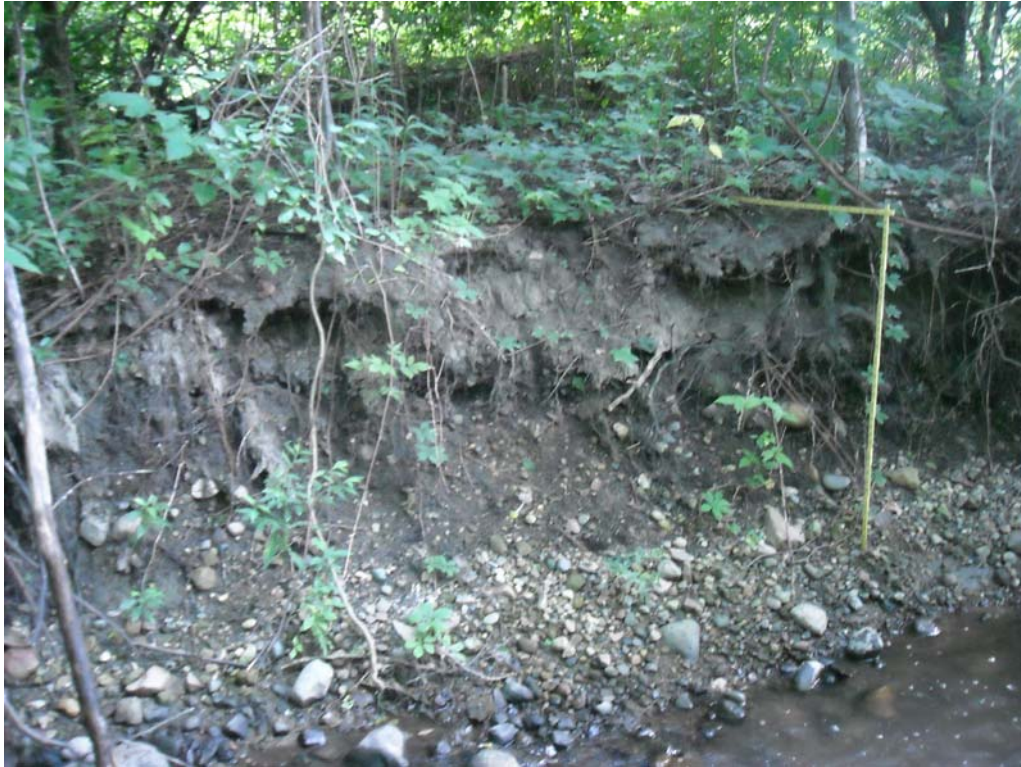
Picture: 379

Bank Failure, Bank Height = ~ 3.5', BEHI = 34/Very High

Location: **Middle Branch Rouge River**

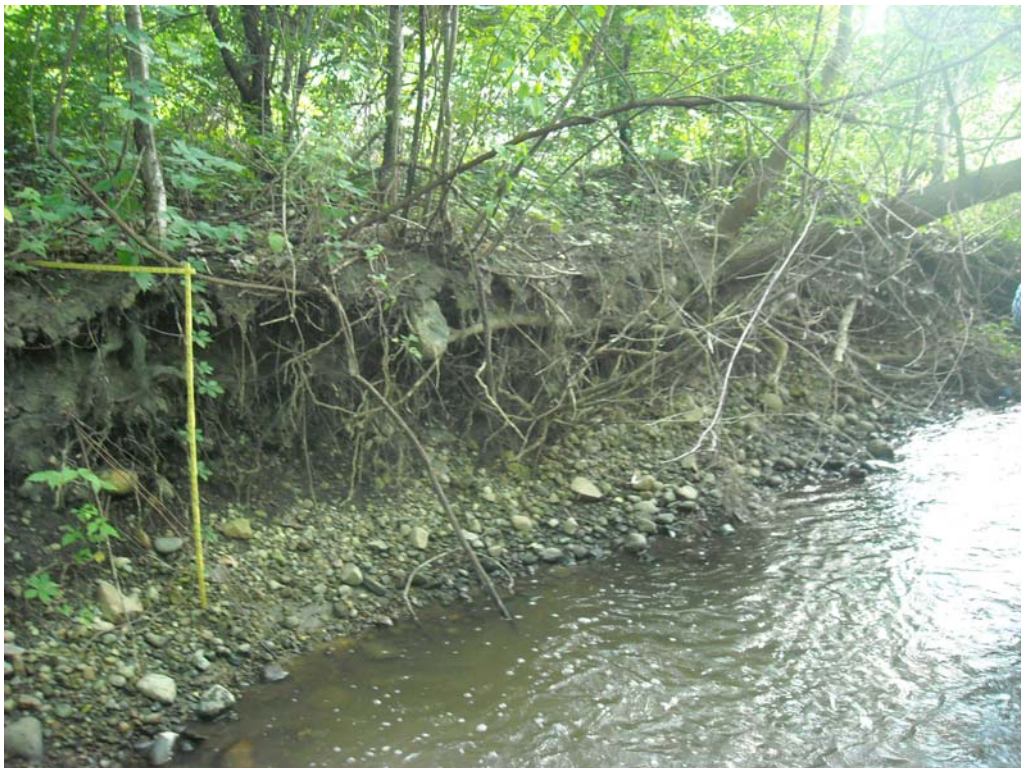
Undercutting Bank, looking downstream

Location: **Middle Branch Rouge River**

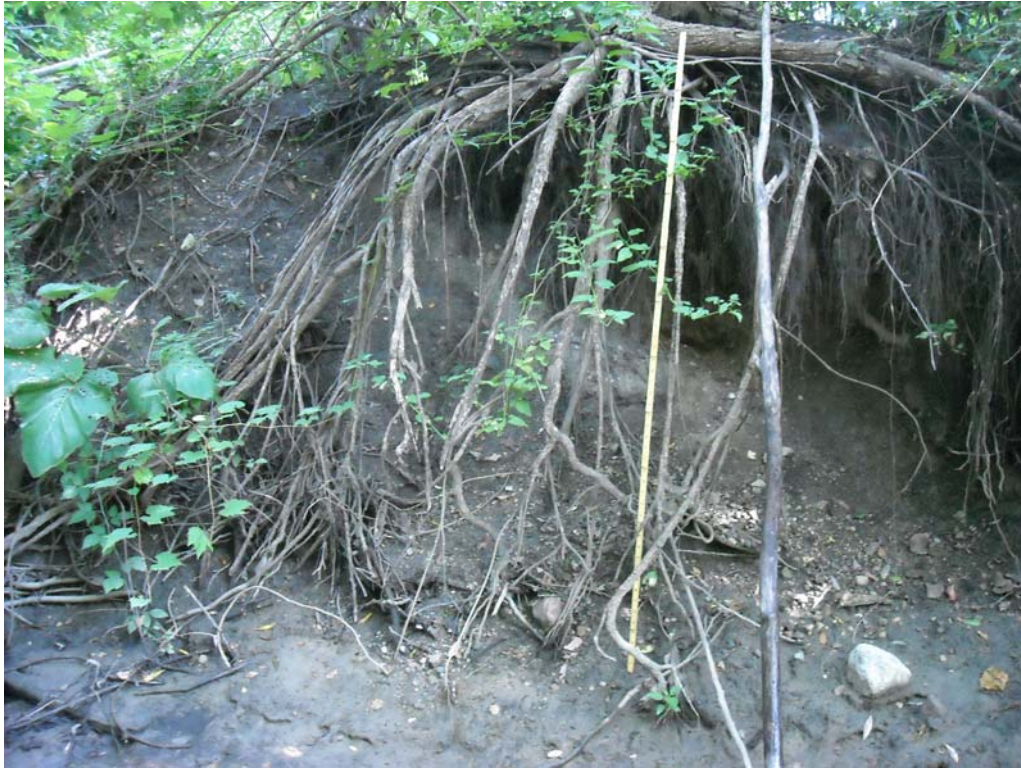
Picture: 408

Undercutting Bank, Bank Height = ~ 7', BEHI = 29/Very High

Location: **Middle Branch Rouge River**

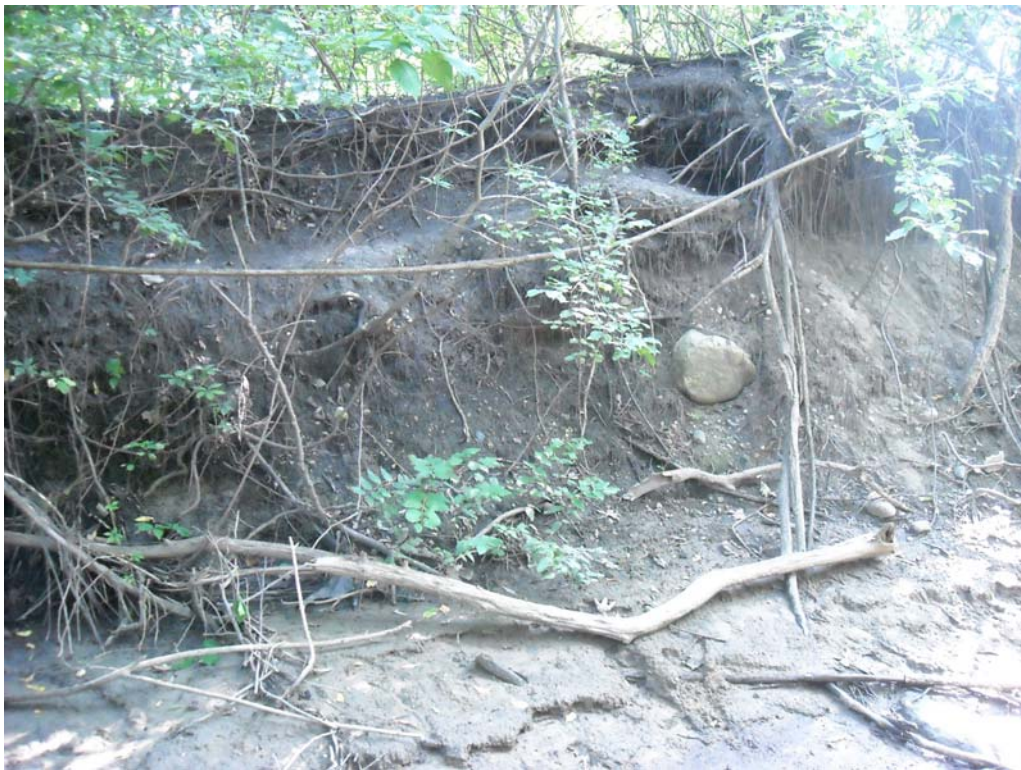
Mass Wasting at Site 14

Location: **Middle Branch Rouge River**

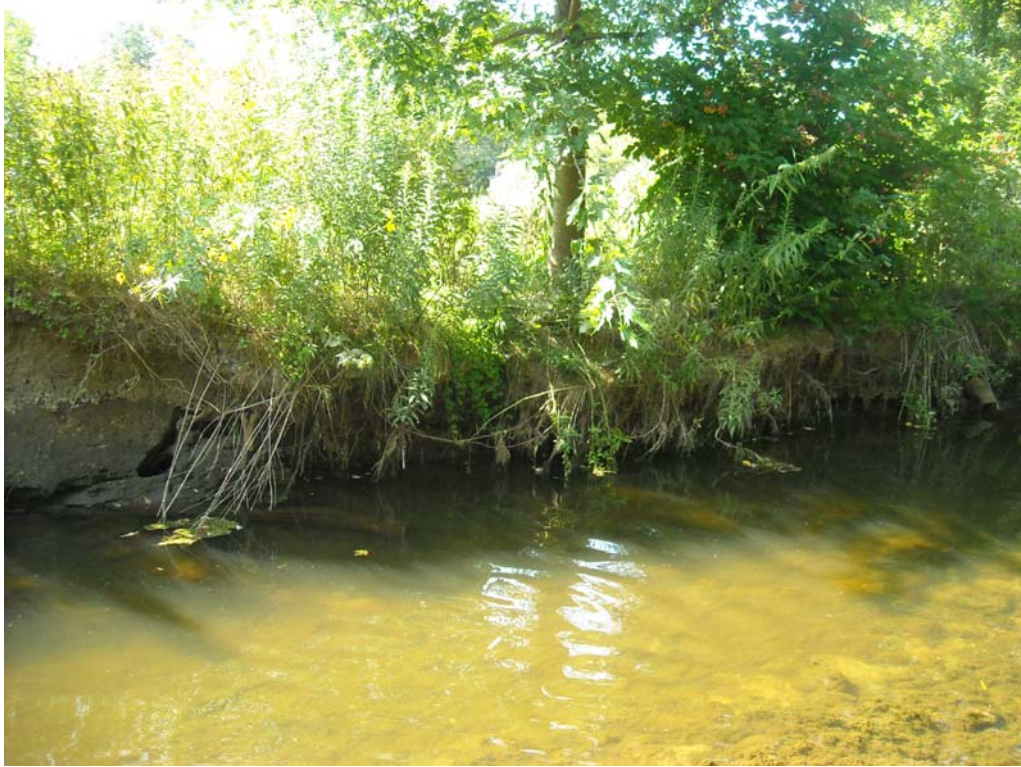
Picture: 476

Outside Meander Erosion & Undercutting Bank, Bank Height = ~ 3.5', BEHI =31/Very High

Location: **Middle Branch Rouge River**

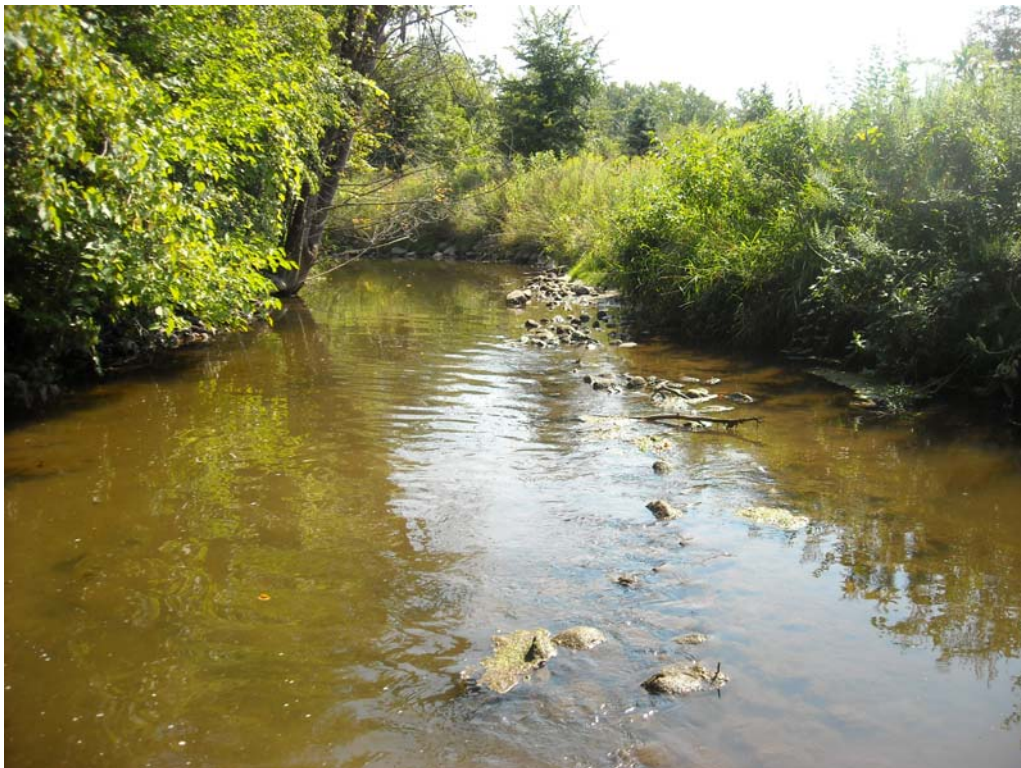
Riprap in channel showing pre-erosion bank location (looking downstream)

Location: **Middle Branch Rouge River**
