MEMORANDUM

SUBJECT: LAKESHORE PARK MOUNTAIN BIKE BRIDGE SURVEY REPORT
DATE: JANUARY 11, 2010

Lakeshore Park Mountain Bike Bridge Survey Fall 2009

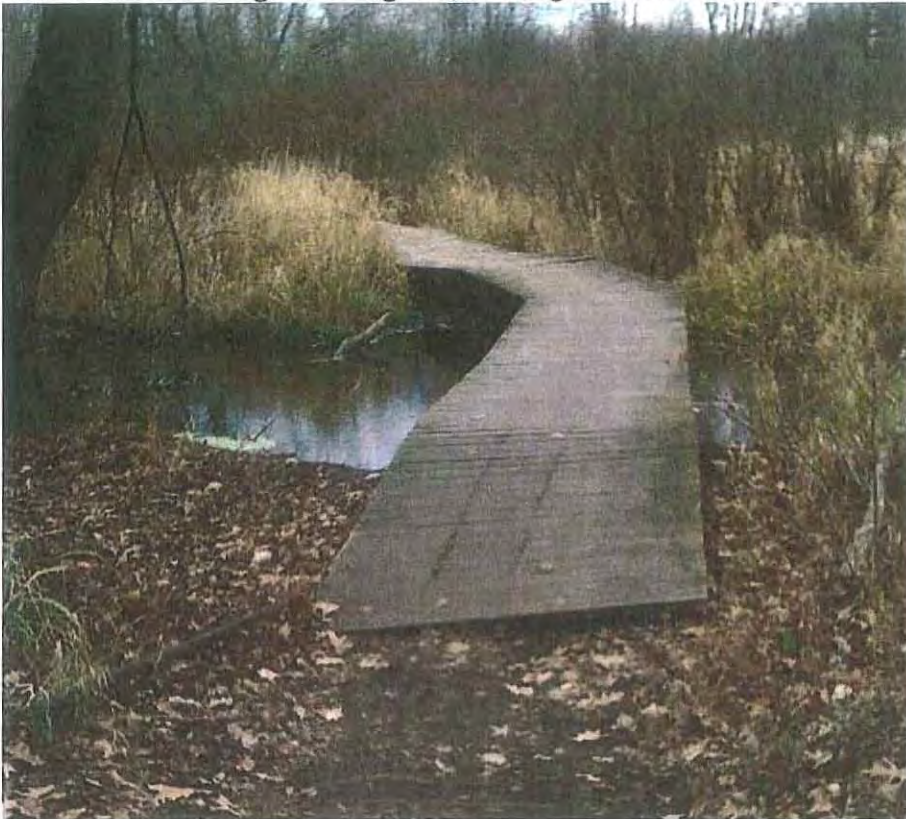
Bridge #1 is one of the oldest bridges on the trail and has been part of the mountain bike trail system since its inception. It is a 135 foot long span, including entry and exit ramps, that crosses the Rouge River tributary and low lying seasonal wetlands at the beginning of the 754 loop. The bridge is used to bring the mountain bike trail to the west side of the tributary into the meadow area of 754. The bridge is 5 ft in width, which permits passing oncoming traffic and is appropriate considering its length and the chance of encountering others during a crossing. This bridge is a favorite among mountain bikers due to its curves, the open views, length, and the sinuous profile. This bridge has good access from the trailhead by following the 2 track all the way to the stream.

Here’s a recent image of Bridge #1, looking towards the west:

The condition of the bridge is generally good, with some frost heave and settling of supporting piers. Also in its early years, this bridge was used to carry park maintenance equipment to the meadow area, and perhaps the piers were not sufficient for that task. One pier in particular has settled more than others, and while it is stable we are anticipating repairing it during a future trail day. There has been little new movement year to year.

Work Item	Description	Priority
1	Bridge #4 needs to be replaced / rebuilt to address structural concerns.	Medium
2	A supporting pier in Bridge #1 has settled and needs to be replaced. Since this is in a wetlands area, sistering an additional 4x4 to the existing pier would have the least impact and cost.	Low
3	We should consider replacing the center section of bridge #9 with a more robust structure, allowing us to avoid piers within the stream bed that have settled.	Low

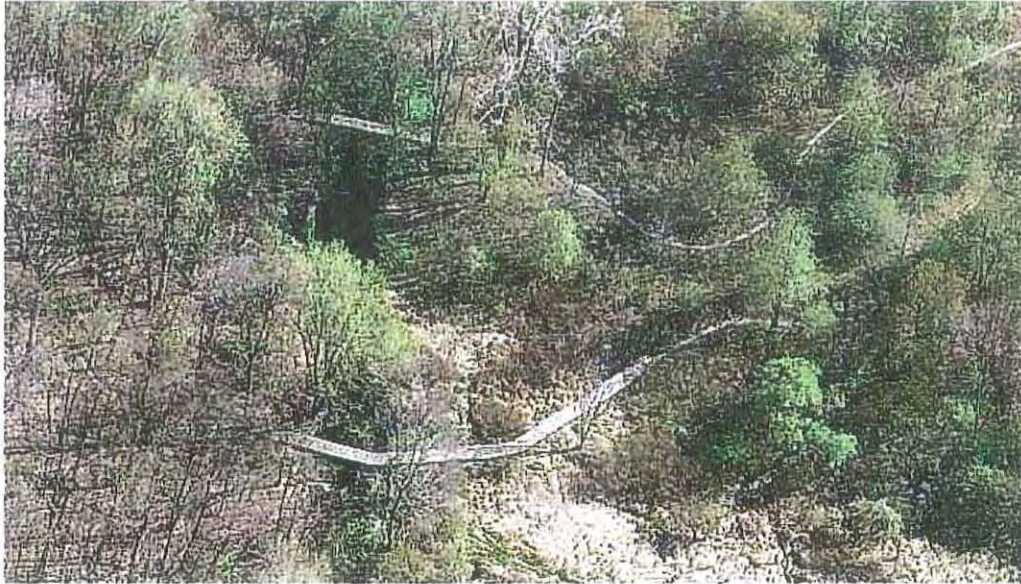
This is a recent overhead view, showing Bridge #1 towards the bottom and Bridge #6 towards the top. (Bridge #7 is just to the left of Bridge #6, but is hidden in trees.)

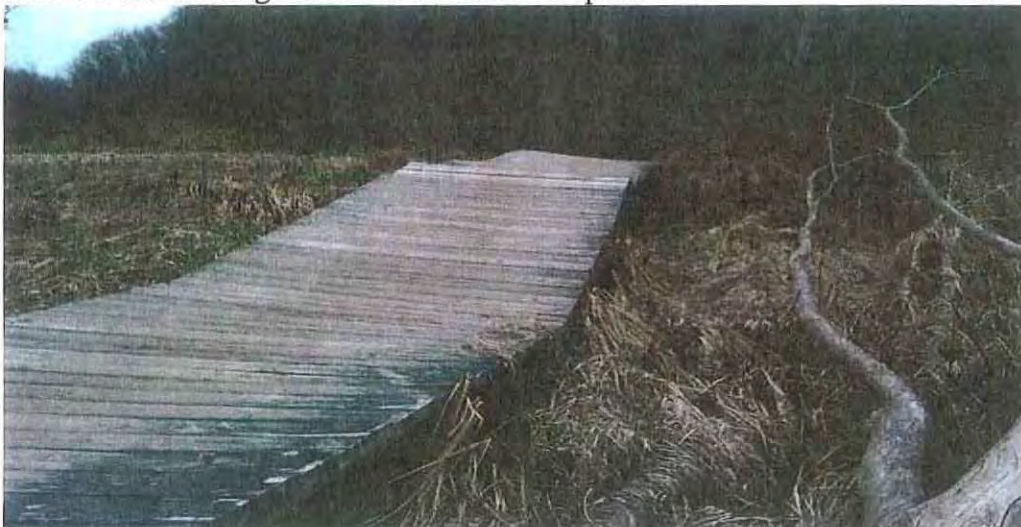
Here's a recent image centered on the settled pier:

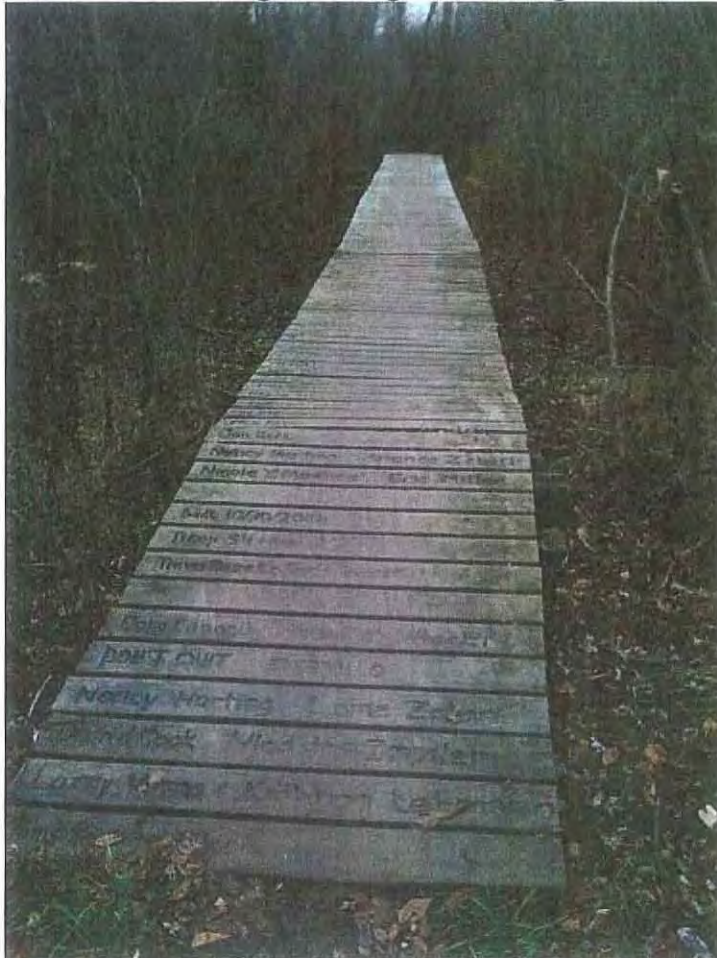
Bridge #2 was the second bridge that was funded by the MMBA/Eagle Scout "buy a plank" fundraising project. This bridge was built in May of 2004 before first MMBA mountain bike race at Lakeshore Park and was put in to avoid multi-directional traffic coming to and from the Lost Loop section of trail. It is an 85 foot long span, including entry and exit ramps, that crosses low lying seasonal wetlands at the beginning of the Lost Loop. Together with Bridge #3, this bridge brings the mountain bike trail back to the east side of the tributary in the south end of the park, traversing from the meadow areas of 754 into the higher ground towards the east. The bridge is 4 ft in width and fairly springy due to the distance between supporting piers and the nature of its construction. This bridge is best accessed from the retaining pond access road on the north side of 12 mile, where an old closed but passable section of trail leads directly to this area.

Here's a recent image of Bridge #2, looking towards the east:

The condition of the bridge is good. There has been little change year to year.

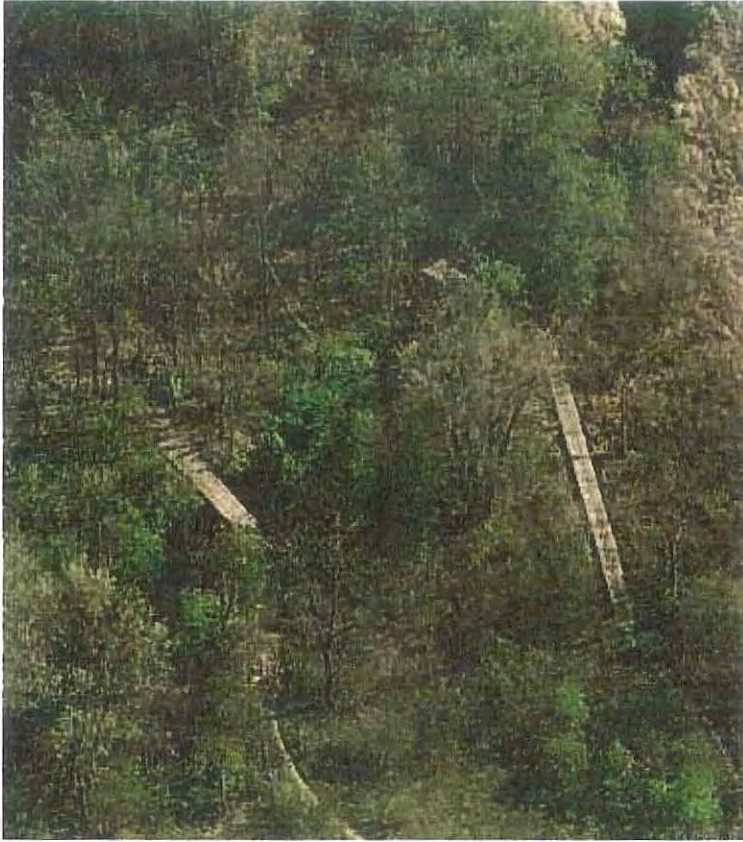
This is a recent overhead of this area, with bridge #2 and #3 towards the right, and Bridge # 4 and #6 towards the left:

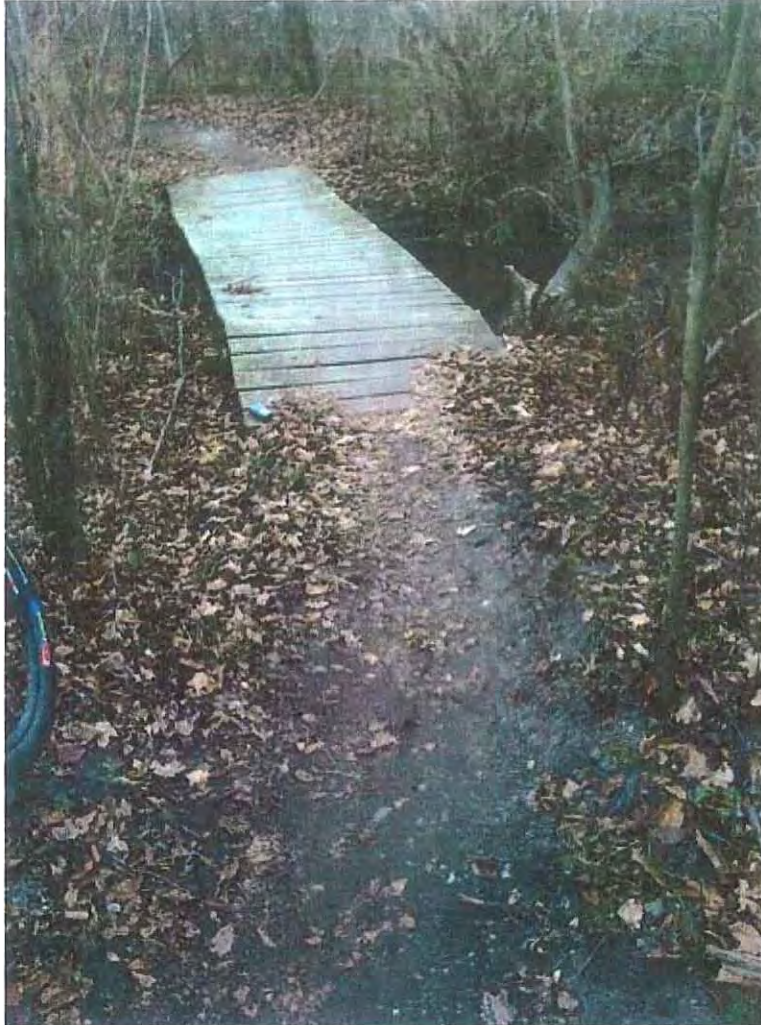
Bridge #3 was also built for the first MMBA mountain bike race, just before Bridge 2 was built. It is a 20 foot long span that immediately follows Bridge #2 at the beginning of the Lost Loop that spans the Rouge River tributary. The bridge is 4 ft in width, which is appropriate considering its short length and the minimal chance of encountering others during a crossing. This bridge is best accessed from the retaining pond access road on the north side of 12 mile, where an old closed but passable section of trail leads directly to this area.

This is a recent image of Bridge #3, looking towards the east:

The condition of the bridge is good. There has been little change year to year.

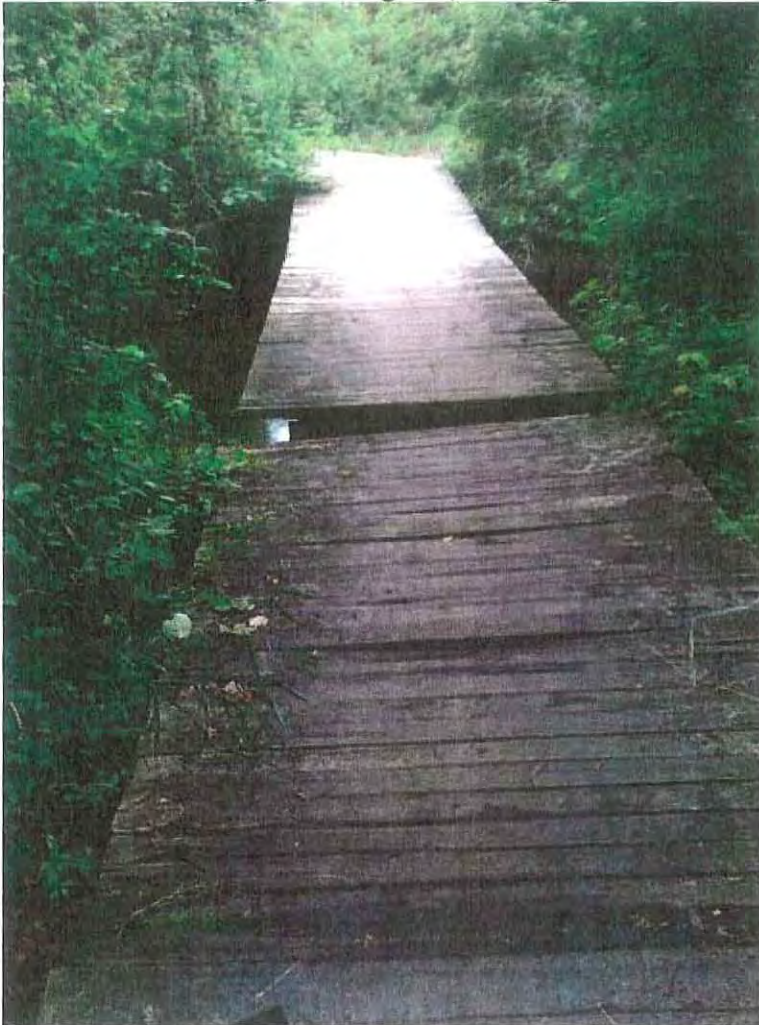
Bridge #4 is a 38 foot span, including entry and exit ramps, that brings the mountain bike trail back west across the Rouge River tributary in Lost Loop. Along with Bridge #1, this bridge (and Bridge #5) has been a part of the trail since the mountain bike trail has been in place. The bridge is 5 ft in width. This bridge is best accessed from the retaining pond

This is a recent image of Bridge #4, looking towards the west:

The condition of the bridge is generally poor, with cracked stringers and rotten planks. An emergency repair to replace broken planks was undertaken by the City of Novi in fall 2009. This span is due to be replaced as part of the MMBA Spring 2010 trail work.

Of these identified work items, only item #1, the replacement of Bridge #4, is of near term concern. We anticipate replacing this bridge during our MMBA Spring Trail Day.

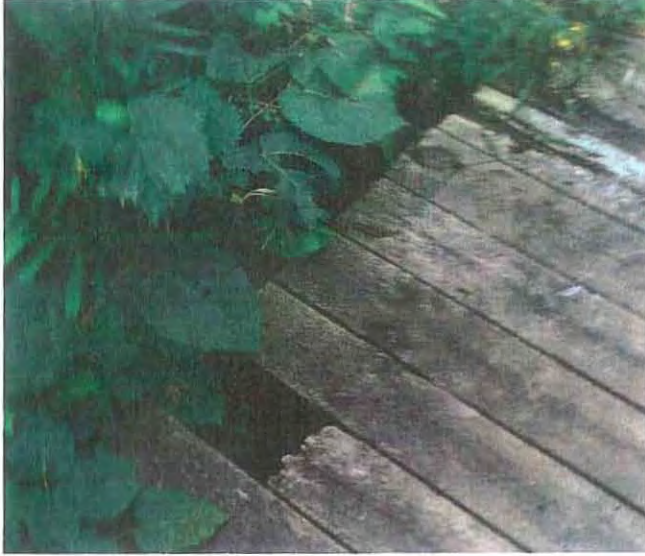
This is a recent image of the bridge planking:

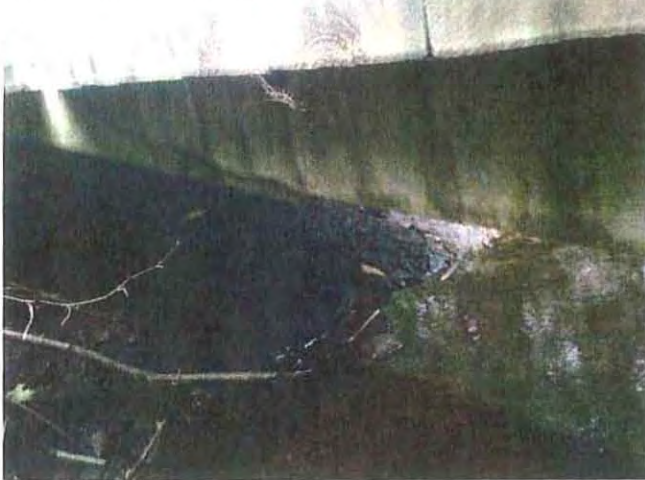
This is a recent image of a stringer under the bridge:

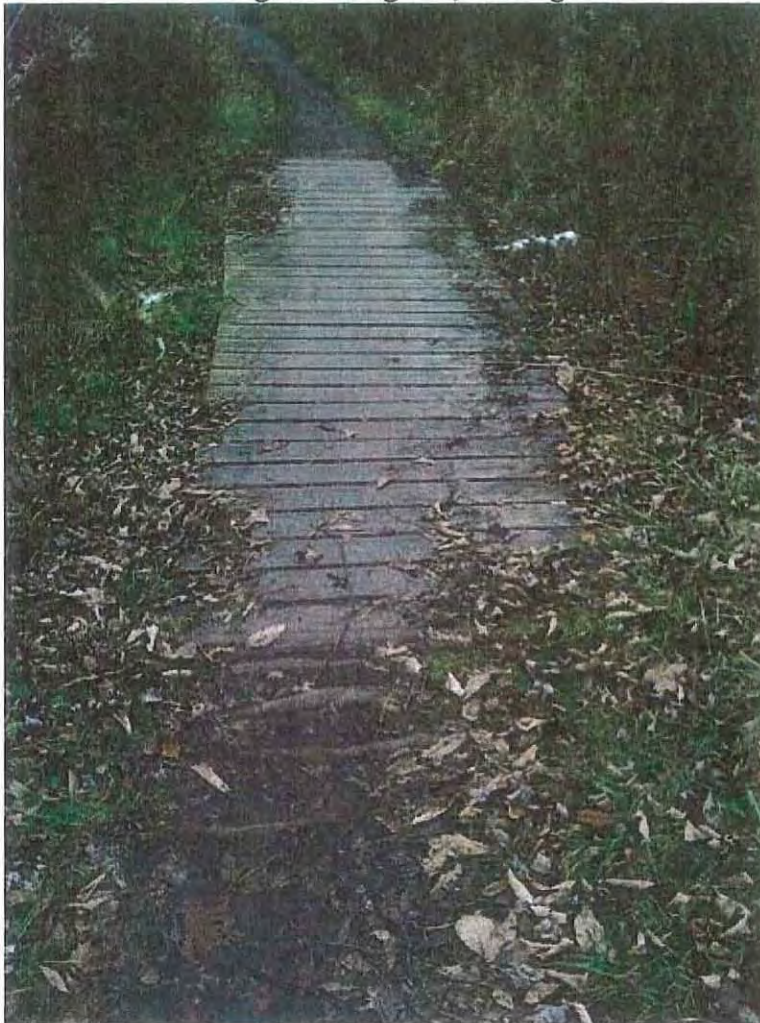
Bridge #5 is a short 17 ft long boardwalk that immediately follows bridge #4 and crosses a seasonal wet area. The boardwalk is 4 ft in width. This boardwalk is best accessed from the retaining pond access road on the north side of 12 mile, where an old closed but passable section of trail leads directly to this area.

This is a recent image of Bridge #5, looking southwest:

The condition of the planks on this boardwalk is generally good. Supporting stringers are not inspected as they are mostly buried, but the boardwalk appears structurally sound.

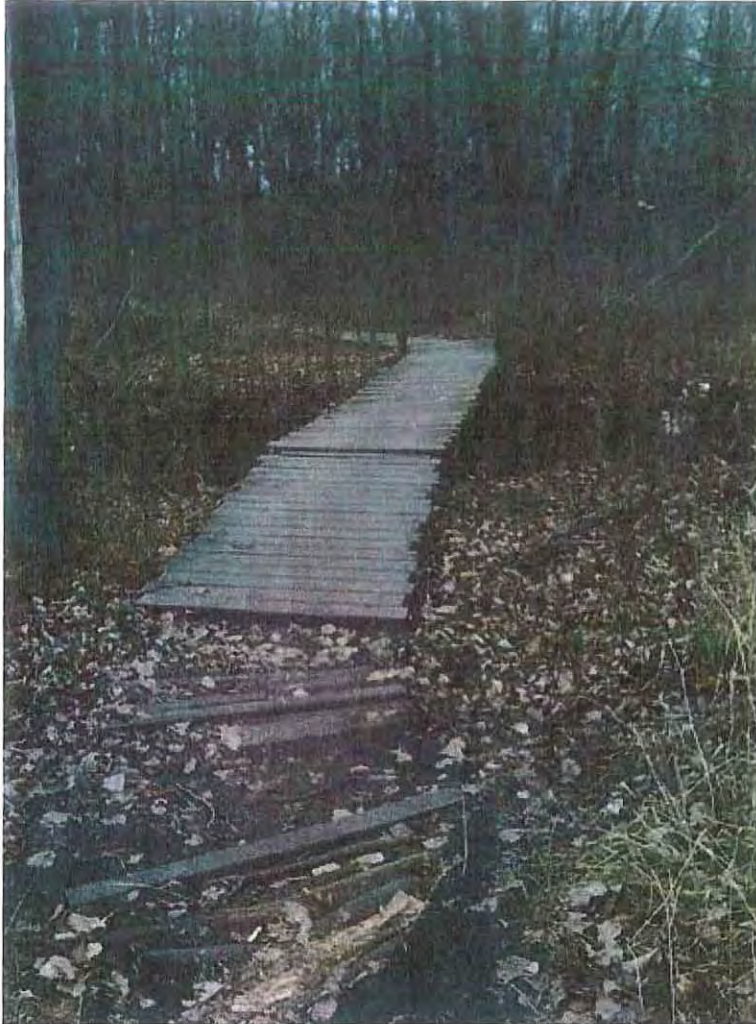
Bridge #6 and Bridge #7 were built by MMBA members in May of 2005 for the second MMBA Mountain Bike race. These were built to eliminate the water crossing that was in the first race by giving riders a return bridge from the 754 loop, eliminating 2-way traffic. Bridge #6 is a 45 ft long bridge that crosses the Rouge River tributary and together with Bridge #7 bring the mountain bike trail back to the east of the Rouge River tributary for the remainder of the trail. This bridge is 4 ft in width. This bridge has good access from the trailhead by following the 2 track all the way to the stream.

This is a recent image of Bridge #6, looking east:

The condition of the bridge is generally good. There has been little change year to year.

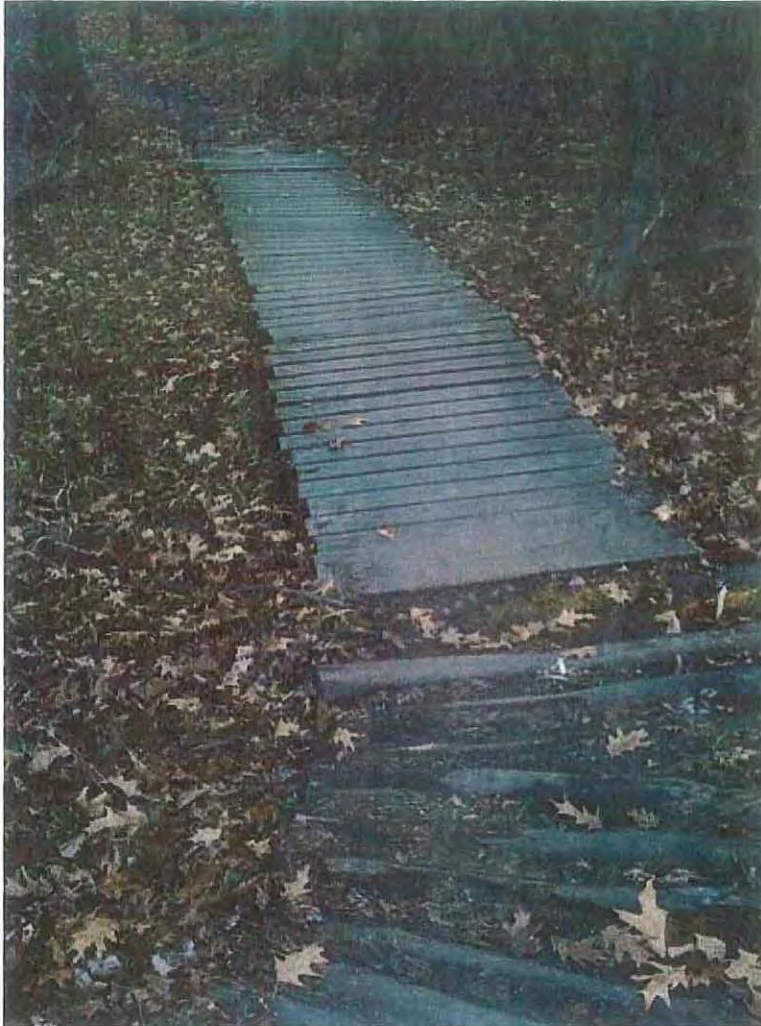
Bridge #7 is a 22 ft long, 4 ft wide span that immediately follows Bridge #6 and crosses seasonally wet lowland. Together with Bridge #6, this brings the mountain bike trail back to the east of the Rouge River tributary for the remainder of the trail. This bridge has good access from the trailhead by following the 2 track all the way to the stream.

This is a recent image of Bridge #7, looking northeast:

The condition of the bridge is good. There has been little change year to year.

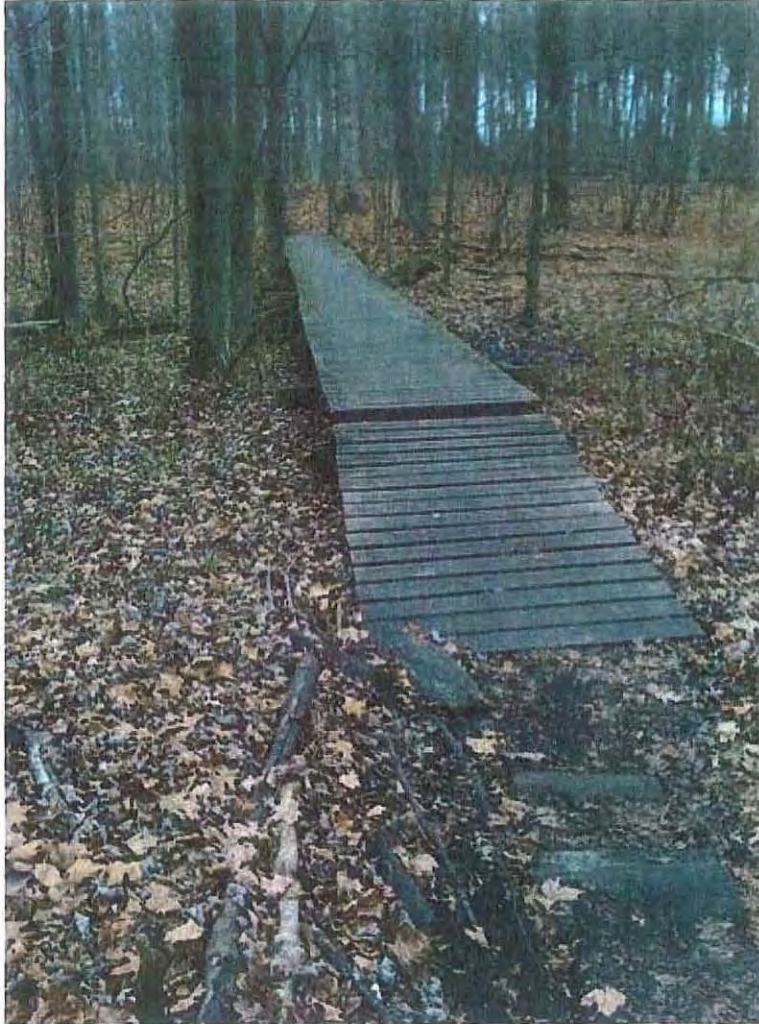
This was the first bridge that was funded by the MMBA/Eagle Scout "Buy a Plank" fundraising program and was built mostly by the Eagle Scouts. This bridge was one of the first to be put in when the mountain bike trail was re-connected after the Sandstone settlement, and it eliminated 2-way traffic on Bridge #9. Bridge #8 is a 67 foot span,

This is a recent image of Bridge #8, looking southeast:

The condition of the bridge is generally good. There has been little change year to year.

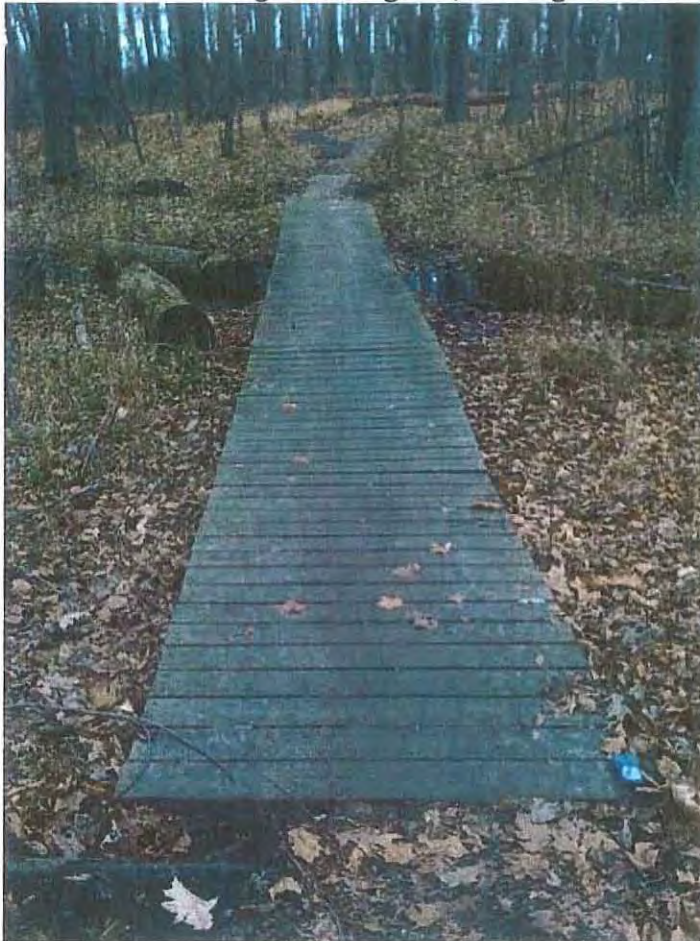
Bridge #9 is one of the older bridges at Lakeshore Park and has been in place since the mountain bike trail has been in use. Bridge #9 is a 42 foot span at the end of the Swamp loop that crosses a shallow flowing stream that drains the central wetlands area of the park towards the Rouge River. This bridge brings the mountain bike trail back from the crater area to the remainder of the trail. This bridge is 4 ft in width, which is adequate considering the length of the bridge and the clear sightlines which minimize conflicting traffic. This bridge has good access from the trailhead by following the rather rustic 2 track all the way to the stream.

This is a recent image of Bridge #9, looking northwest:

The condition of the bridge is fair. This bridge appears structurally sound, but the central piers in the stream have sunk and the stringers are now partially immersed during periods of high water. We have been watching this for some time and have not seen any recent changes, but anticipate replacing the center section of this bridge to remove the need for the piers within the stream sometime in the future.

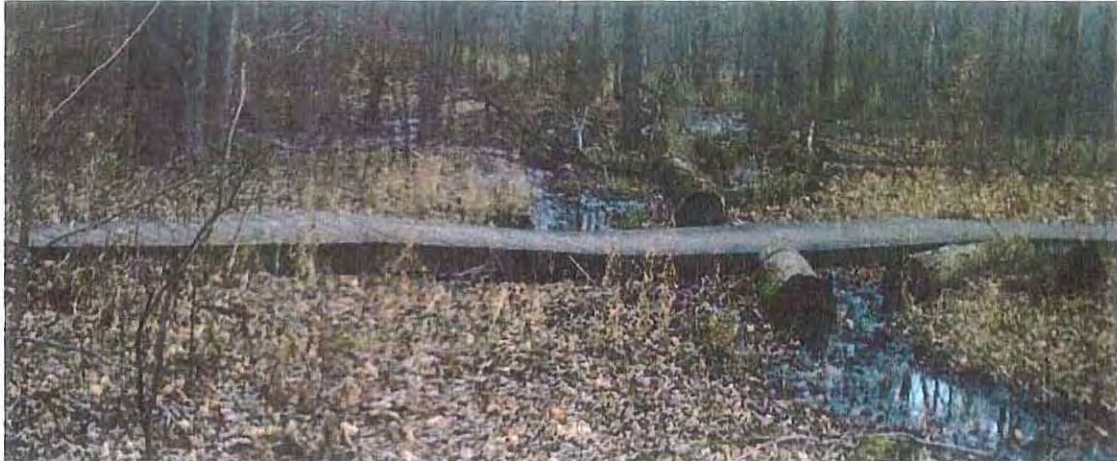
This is a recent image of the profile of Bridge #9 highlighting the settled center section relative to the stream:
